REPORT NO. ST35438R-63
TASK NO. RAE20P031
PROBLEM NO: 031-AE22-33
DATE 1 Aug 1963

NAVAL AIR TEST CENTER TECHNICAL REPORT

THIRD INTERIM REPORT

(6) TEST FLIGHT OF PILOTS' FLASHBLINDNESS
HELMETS, GOGGLES, GLASSES, AND ASSOCIATED SYSTEMS.

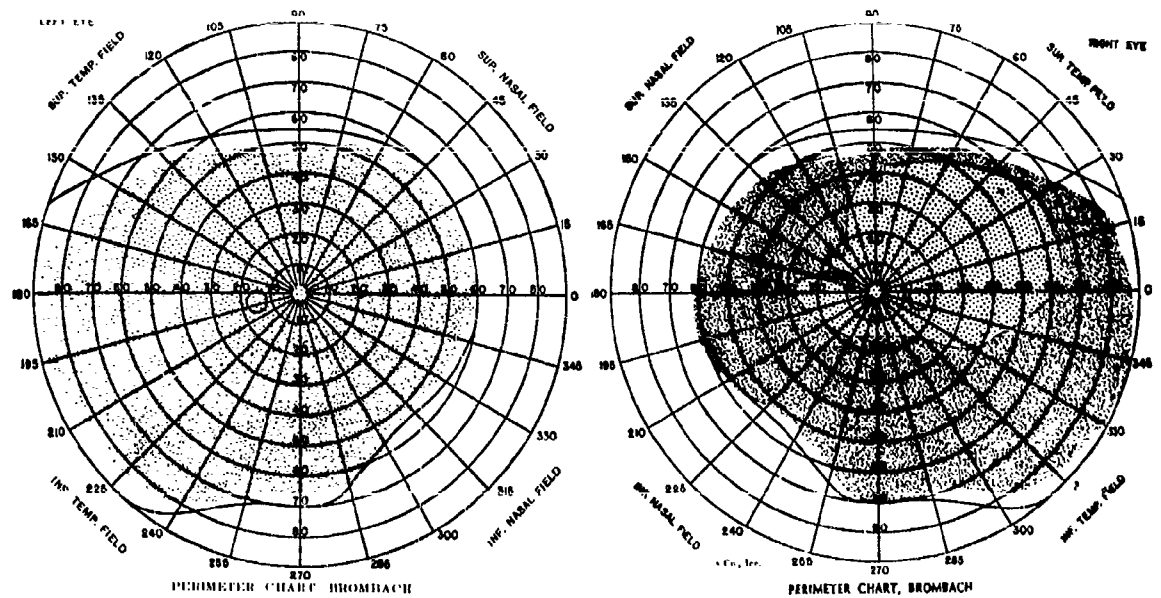
Figure 5
Composite Perimeter Chart

16. Perimeter tests revealed a marked reduction of peripheral vision with the EMG, as indicated in the composite perimeter charts (figure 5). The over-all reduction of the nasal fields and the asymmetrical reduction of the right superior nasal field was consistent for all subjects. These reductions of nasal fields were caused by the 1 in. separation between the goggle lenses across the bridge of the nose and by the motor release lever over part of the right lens. Repeated perimeter tests on any given subject showed minor jagged deviations in outline in the temporal fields, caused by shutter interference. The variations in superior and inferior fields were probably caused by the shutters in the lenses. Other quadrants of reduced vision varied with subjects. The differences of facial anatomy, particularly the nasal contours, accounted for the variation between subjects. Flight tests of the goggles were restricted to dual control aircraft because of the severe reduction of peripheral vision. The EMG are unacceptable because of the reduction they create in the wearer's field of vision.

18. Evaluations of instrument, console, and control visibility conducted in the cockpits of various aircraft verified the laboratory EMG perimeter studies. All tests were conducted with the seat adjusted so as to align the subject's optic axes with the design eye plane. The reduction of visual fields by the EMG caused most subjects to assume a head down position to see the essential flight instruments. This position was both uncomfortable and unsafe.
